# **Intel® Mobile Celeron™ Processor at 550 MHz, 500 MHz, 450 MHz, and 400A MHz Specification Update**

Release Date: May 2000

Order Number: 245421-004

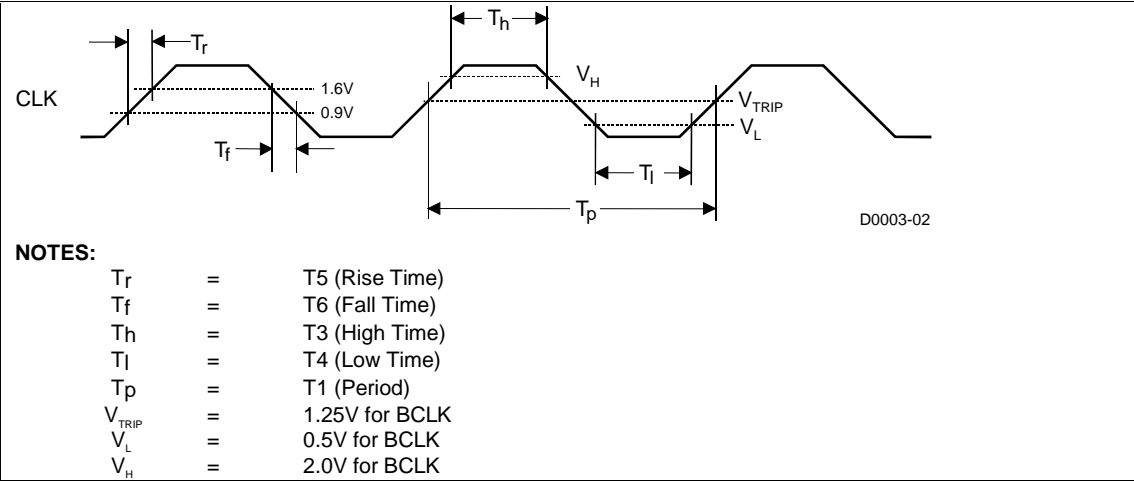
Figure 6. BCLK Timing Waveform

Symbol	Parameter	Min	Typ	Max	Unit	Figure	Notes
	System Bus Frequency		100		MHz		
T1	BCLK Period		10		ns	Figure 6	Note 2
T2	BCLK Period Stability			$\pm 250$	ps		Notes 3, 4
T3	BCLK High Time	2.70			ns	Figure 6	at >2.0V
T4	BCLK Low Time	2.45			ns	Figure 6	at <0.5V
T5	BCLK Rise Time	0.175		0.875	ns	Figure 6	(0.9V – 1.6V)
T6	BCLK Fall Time	0.175		0.875	ns	Figure 6	(1.6V – 0.9V)

1. All AC timings for GTL+ and CMOS signals are referenced to the BCLK rising edge at 1.25V. All CMOS signals are referenced at 0.75V.
2. The BCLK period allows a +0.5 ns tolerance for clock driver variation.
3. Not 100% tested. Specified by design/characterization.
4. Measured on the rising edge of adjacent BCLKs at 1.25V. The jitter present must be accounted for as a component of BCLK skew between devices.

For B0 step processors, the  $V_{IH,BCLK}$  Min spec is changed to 2.0V (from 1.7V for A2 step) and  $V_{IL,BCLK}$  Max spec is changed to 0.5V (from 0.7V for A2 step). Due to this, new values are specified for BCLK high and low times for B0 step processors. These modifications affect corresponding specs in Table 12, Table 13, Table 22, and Figure 6 in *Mobile Celeron™ Processor in BGA2 and Micro-PGA2 Packages at 500 MHz, 450 MHz, and 400A MHz* datasheet.

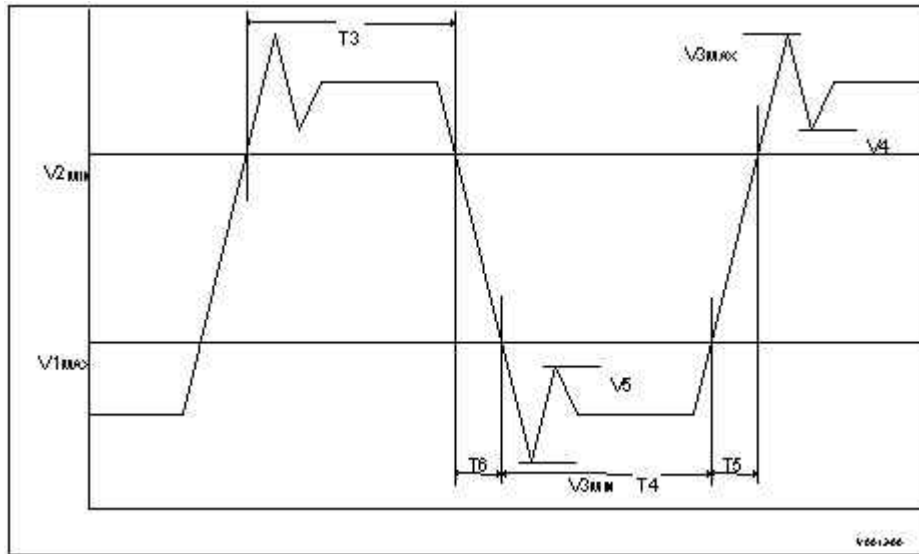
Figure 4. BCLK Waveform at the Processor Core Pins

In Table 18, “BCLK Signal Quality AC Specifications at the Processor Core” of the *Intel® Celeron™ Processor Mobile Module: Mobile Module Connector 2 (MMC-2) at 500 MHz and 450 MHz Datasheet*, Note 3 has changed. Figure 4 “BCLK Waveform at the Processor Core Pins” has also been updated. See below.

3. The rising edge ringback voltage specified is the minimum absolute voltage that the BCLK signal can dip back to after the BCLK signal passes the  $V_{IH,BCLK,MIN}$  (rising) voltage limits. The falling edge ringback voltage specified is the maximum absolute voltage that the BCLK signal can dip back to after the BCLK signal passes the  $V_{IL,BCLK,MAX}$  (falling) voltage limits.
